**BUTLER COUNTY BRIDGE MANAGEMENT SYSTEM
BRIDGE INSPECTION RECORD**

County Bridge Name:
BAUER ROAD - 0.807

Structure File Number:	0931160	Inspected By:	ROGER E. THOMPSON
General Appraisal Operating Status:	4 A	Inspection Date:	0 6 / 2 6 / 0 5
Sufficiency Rating:	44.8	Township:	MILFORD
Inspection No:	2005

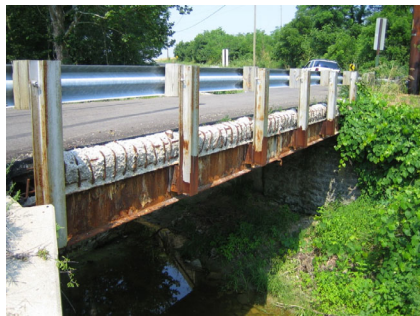
Photo 1

ELEVATION

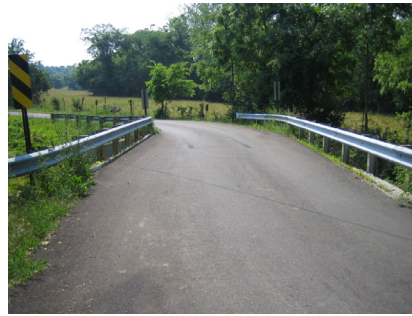
Photo 2

ENDVIEW
