**BUTLER COUNTY BRIDGE MANAGEMENT SYSTEM
BRIDGE INSPECTION RECORD**

County Bridge Name:
HAMILTON NEW LONDON ROAD - 5.029

Structure File Number:	0932183	Inspected By:	ANN M. GRIESSMANN
General Appraisal Operating Status:	3 P	Inspection Date:	0 4 / 1 1 / 0 5
Sufficiency Rating:	33	Township:	ROSS
Inspection No:	2005

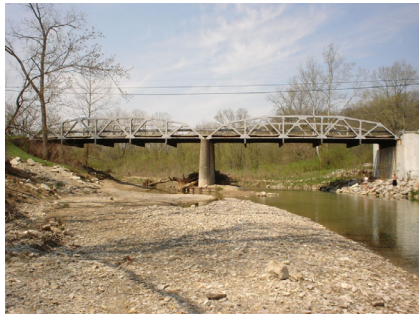
Photo 1

ELEVATION LOOKING WEST.

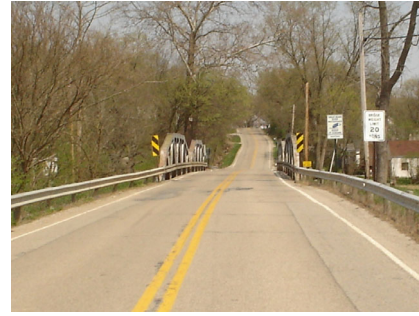
Photo 2

ENDVIEW LOOKING NORTH.
