**BUTLER COUNTY BRIDGE MANAGEMENT SYSTEM  
BRIDGE INSPECTION RECORD**

County Bridge Name:  
INDIAN CREEK ROAD - 1.360

Structure File Number: 0932485  
General Appraisal Operating Status: 4 A  
Sufficiency Rating: 73.9  
Inspection No: 2005

NO. OF SPANS: 1 O.A. LENGTH: 127 FT. DECK WIDTH: 24 FT.  
YEAR BUILT / REHAB: 1967  
STRUCTURE TYPE: CAMEL BACK WELDED STEEL PONY TRUSS AND ASPHALT/METAL DECK WITH STUB ABUTMENTS

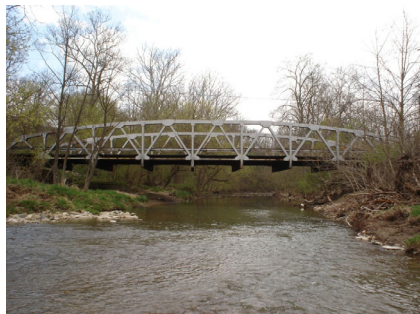
Photo 1

ELEVATION LOOKING EAST.

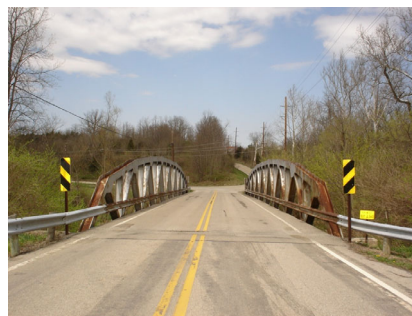
Photo 2

ENDVIEW LOOKING NORTH.
