**BUTLER COUNTY BRIDGE MANAGEMENT SYSTEM
BRIDGE INSPECTION RECORD**

County Bridge Name:
LAYHIGH ROAD - 6.954

Structure File Number: 0932671
General Appraisal Operating Status: 4 A
Sufficiency Rating: 45.9
Inspection No: 2005

NO. OF SPANS: 1 O.A. LENGTH: 61 FT. DECK WIDTH: 24 FT.
YEAR BUILT / REHAB: 1962
STRUCTURE TYPE: STEEL PONY TRUSS WITH METAL DECK AND CONCRETE WALL TYPE ABUTMENTS

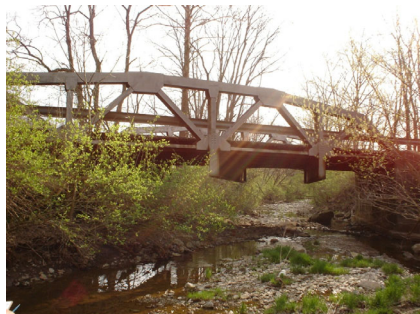
Photo 1

ELEVATION LOOKING EAST.

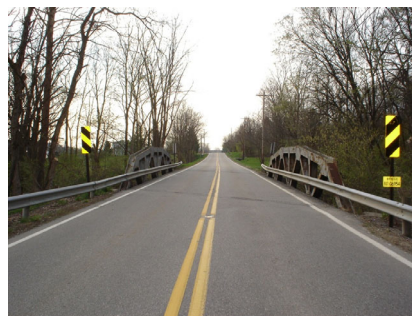
Photo 2

ENDVIEW LOOKING SOUTH.
