**BUTLER COUNTY BRIDGE MANAGEMENT SYSTEM
BRIDGE INSPECTION RECORD**

County Bridge Name:
LESOURDSVILLE WEST CHESTER ROAD - 0.168

Structure File Number: 0932744
General Appraisal Operating Status: 4 A
Sufficiency Rating: 41.3
Inspection No: 2005

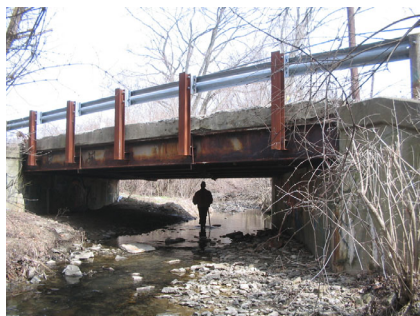
Photo 1

ELEVATION LOOKING EAST.

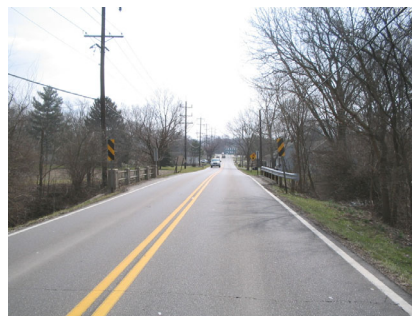
Photo 2

ENDVIEW LOOKING SOUTH.
