**BUTLER COUNTY BRIDGE MANAGEMENT SYSTEM  
BRIDGE INSPECTION RECORD**

County Bridge Name:  
**MORGAN ROSS ROAD - 1.016**

Structure File Number: 0933090  
General Appraisal Operating Status: 4 A  
Sufficiency Rating: 71.8  
Inspection No: 2005

Inspected By: ANN M. GRIESSMANN  
Inspection Date: 04 / 14 / 05  
Township: MORGAN

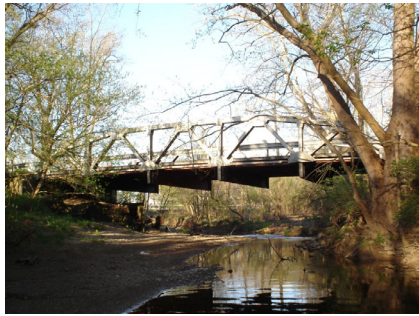
Photo 1

ELEVATION LOOKING WEST.

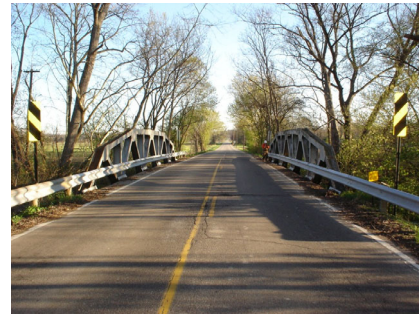
Photo 2

ENDVIEW LOOKING NORTH.
