**BUTLER COUNTY BRIDGE MANAGEMENT SYSTEM  
BRIDGE INSPECTION RECORD**

County Bridge Name:  
ROSS HANOVER ROAD - 1.298

Structure File Number:	0930660	Inspected By:	ANN M. GRIESSMANN
General Appraisal Operating Status:	4 A		
Sufficiency Rating:	40.8	Inspection Date:	0 4 / 1 1 / 0 5
Inspection No:	2005	Township:	ROSS

NO. OF SPANS:	1	O.A. LENGTH:	46 FT.	DECK WIDTH:	28 FT.
YEAR BUILT / REHAB:	1942				
STRUCTURE TYPE:	CAST-IN-PLACE CONCRETE SLAB WITH WALL TYPE ABUTMENTS

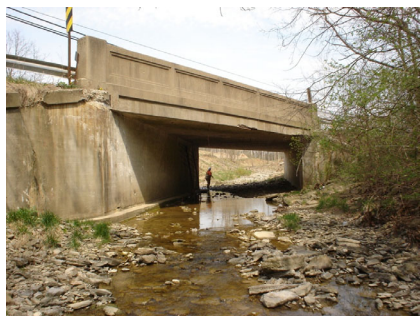
Photo 1

ELEVATION LOOKING NORTH.

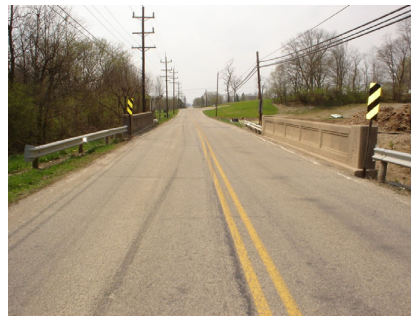
Photo 2

ENDVIEW LOOKING WEST.
